Homecheck Inspection Service

# HOME INSPECTION REPORT

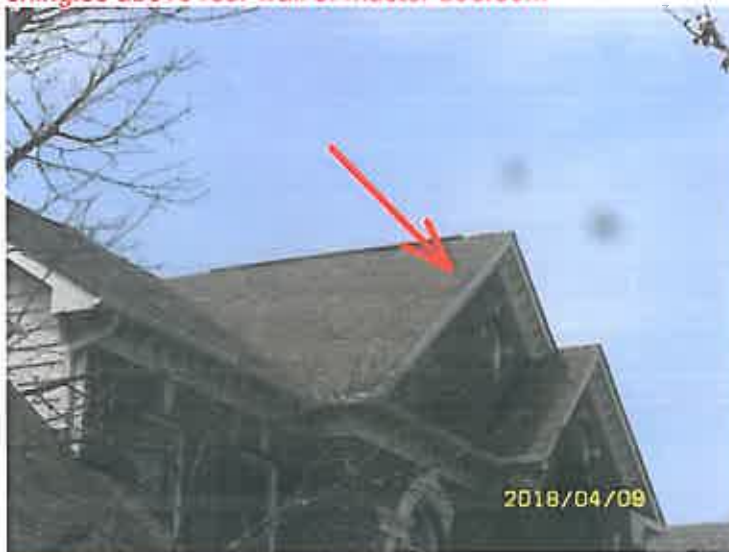
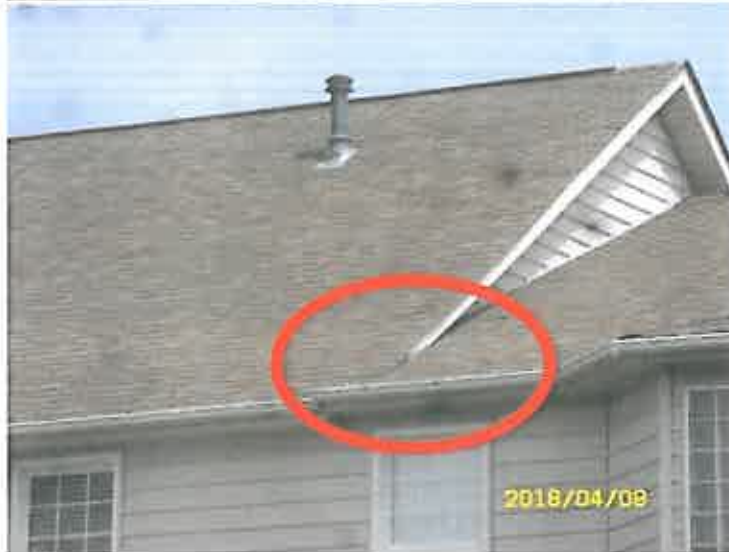
Covering/Material Standard tab shingle. Minor damage at front gable. Has caulked over shingles above rear wall of master bedroom

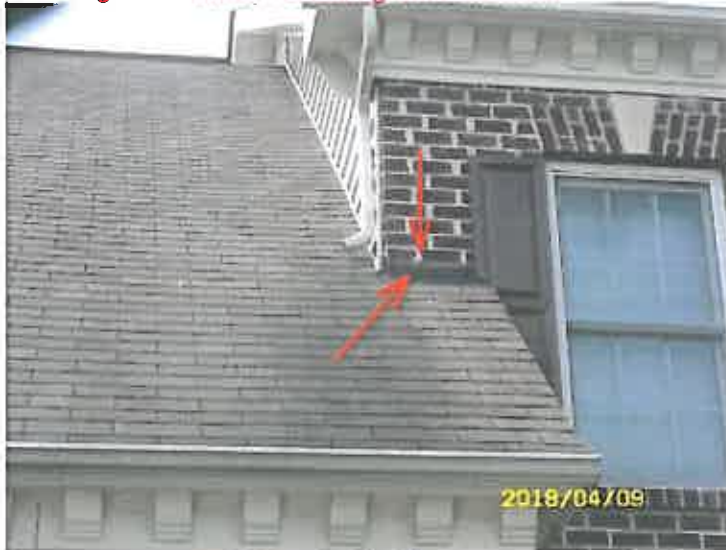
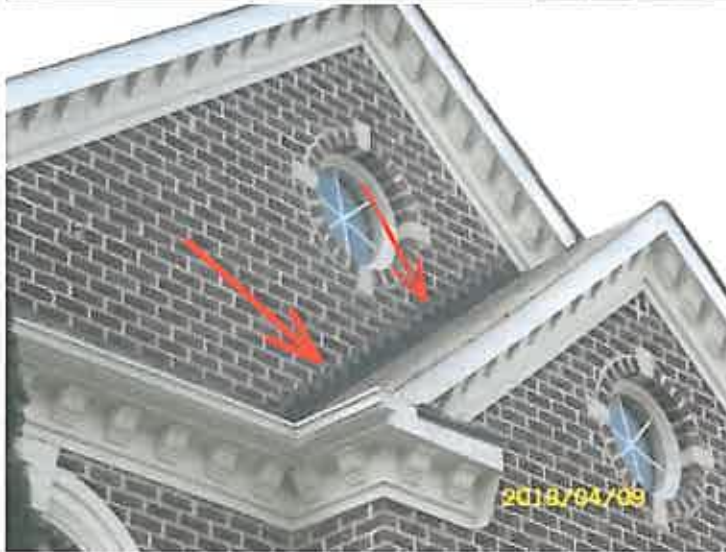
years of age  
Flashing: need minor resealing at front brick

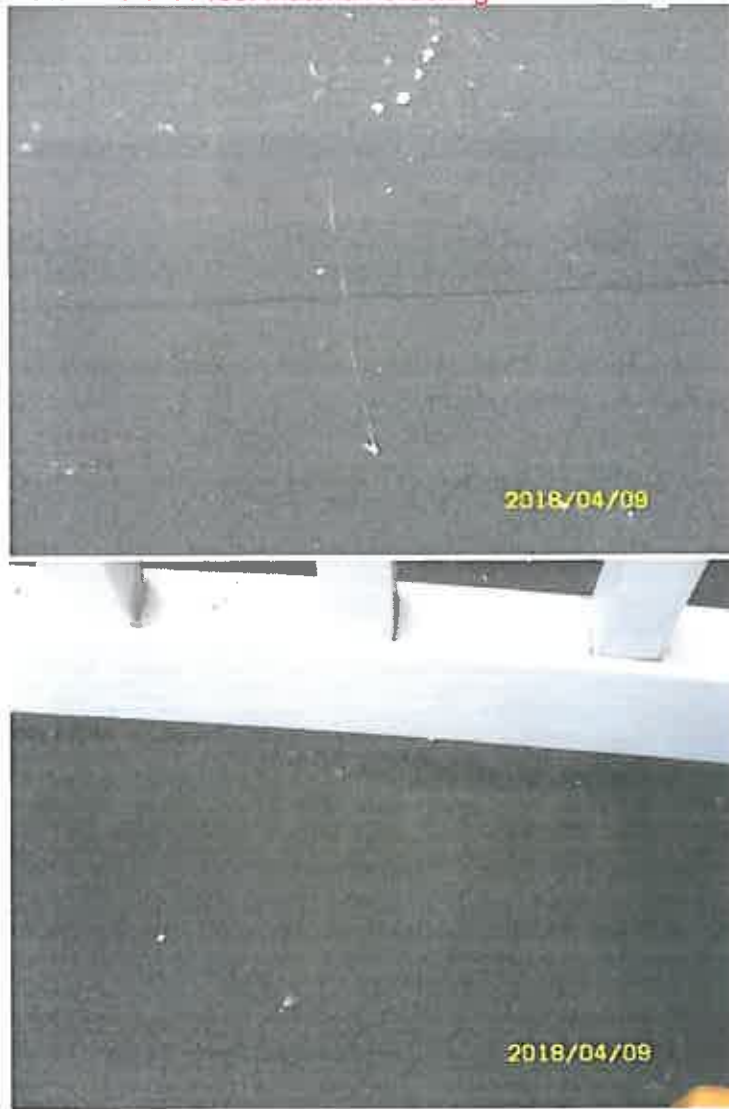
Material: Rolled roof material. Cracking

Approximate Age: Obtain a life expectancy and or repair/replacement estimate

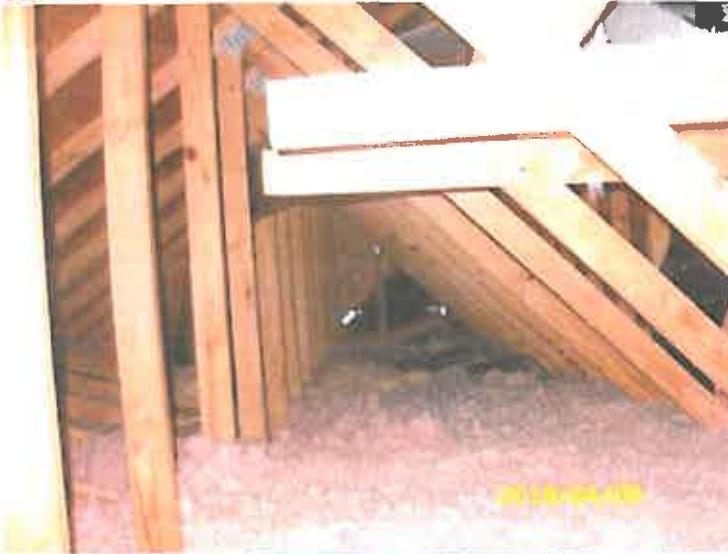
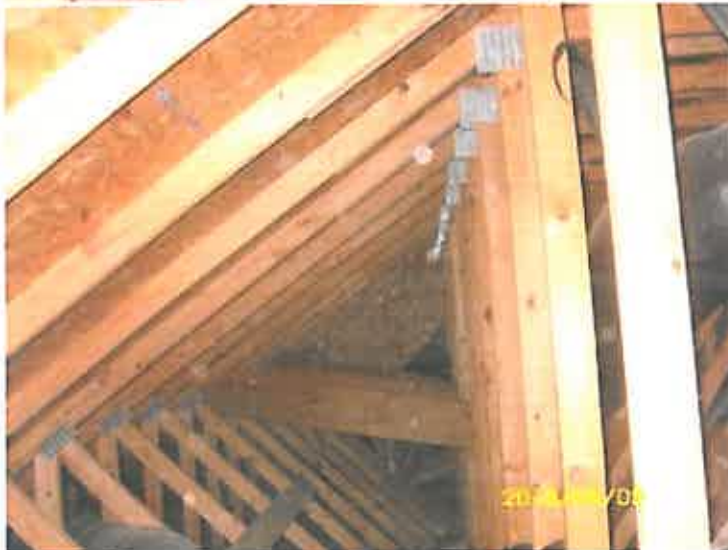
**Batt Insulation some missing at vaulted ceiling**

**Blown In Insulation Displaced in areas, needs redistributing to even up**

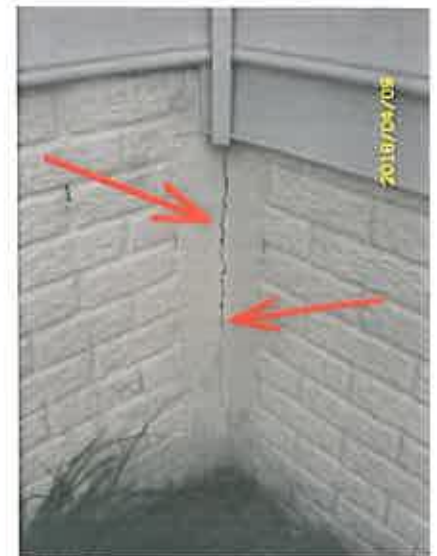
Poured Concrete Foundation hairline cracking in areas. Large crack at rear inside corner, approximately 1/8 inch wide. Needs repair

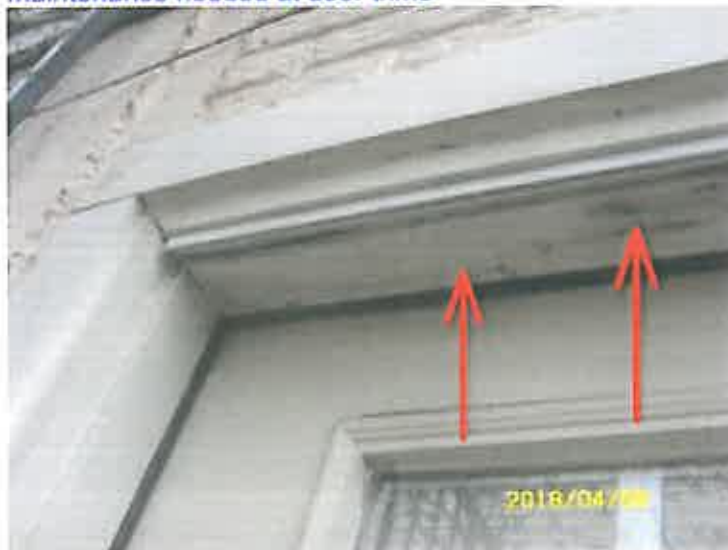
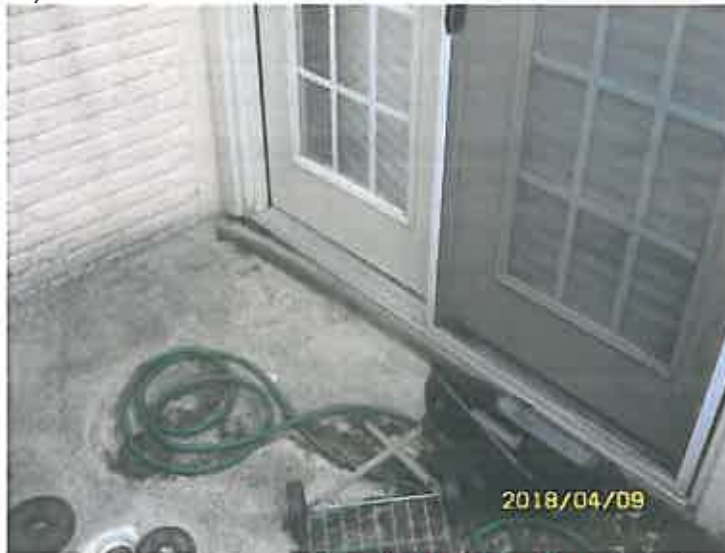
Wood Trims rotted and loose at basement door area. Rotting at sunroom door- maintenance needed at door trims

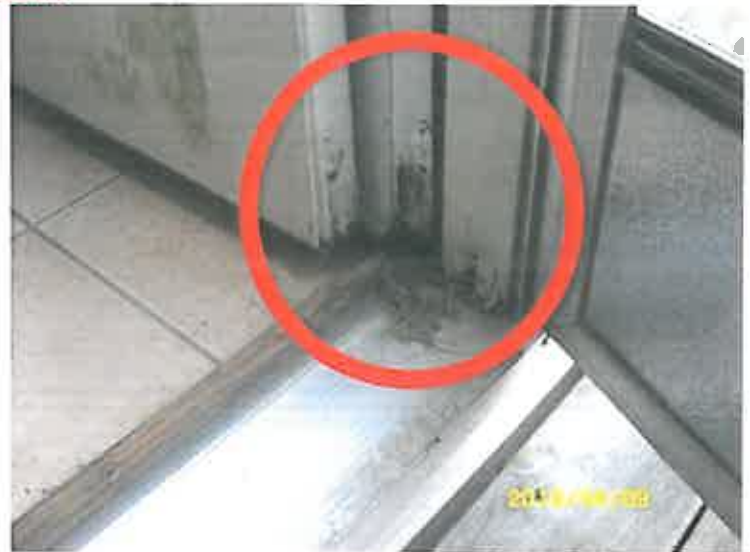
Aluminum Trim Cladding **some loose at roof rakes**  
PVC / MDF Etc. type Trims  
Fascia:  
Soffits: **some loose at upper rear Gable**  
Main Doors: **rotting wood at sunroom entry door .**

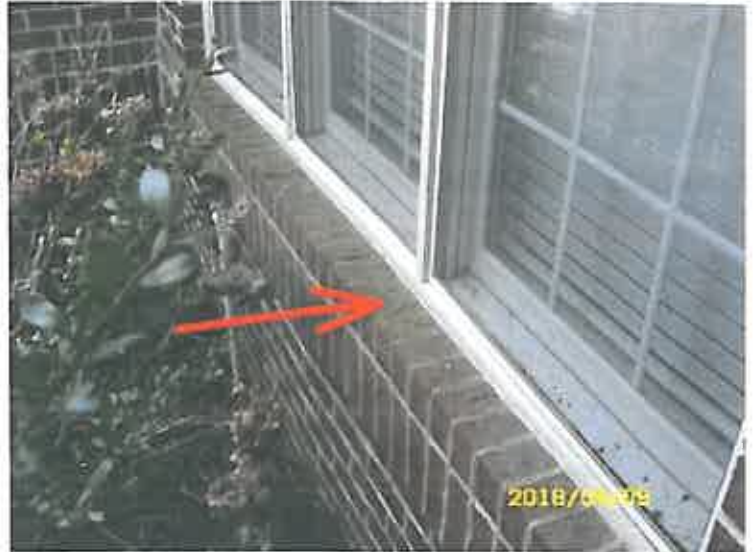
Windows: dining room window appears to be bowed in along brick ledge

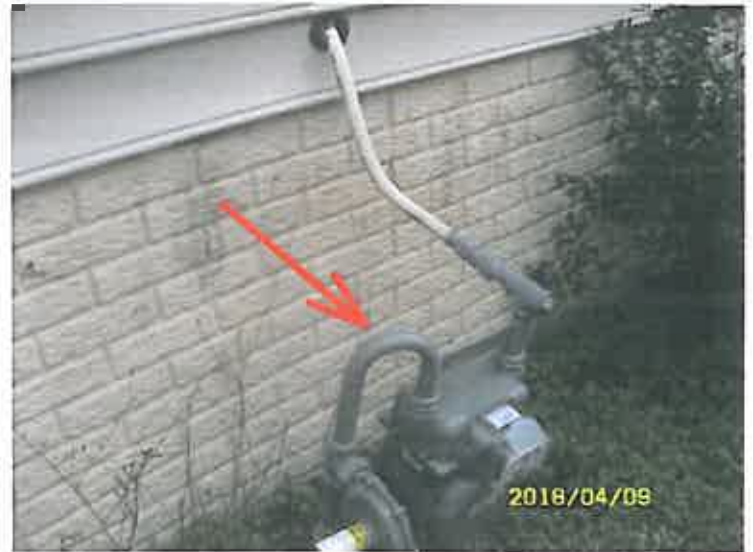
Lighting: not working at front  
GFCI Protected Outlets -  
Vent Covers damaged flap at large kitchen vent.  
Hose Bibs: Not operational  
Gas Meter // Location -  
displaced/out of plumb at exterior,  
right side

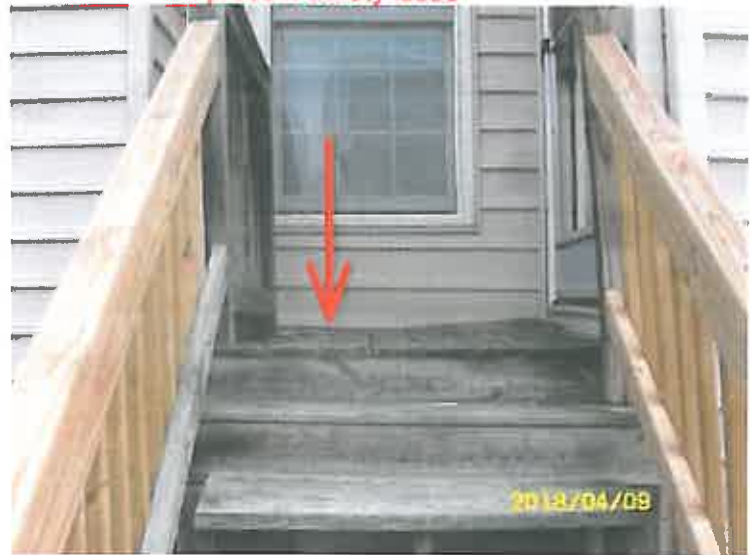
Concrete Driveway  
Concrete Walkway Displaced/sunken  
Concrete/ Masonry Front Porch loose bricks could present safety issue  
Wood Deck unlevel, damaged boards, needs refinishing, loose rails

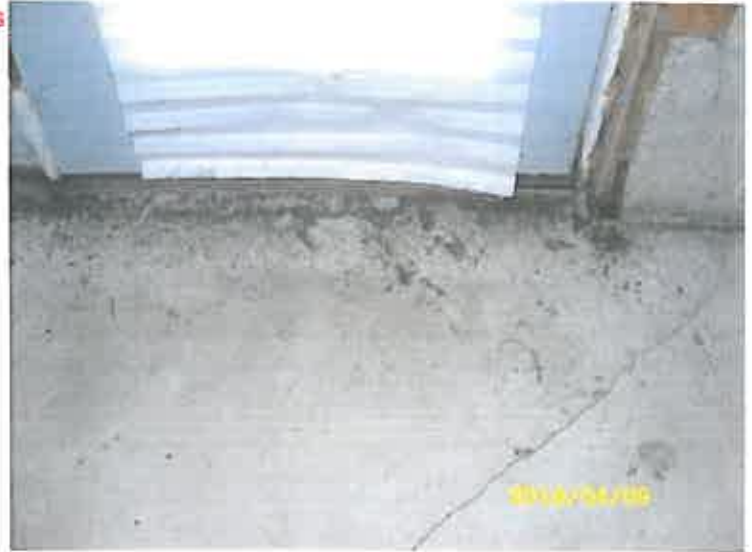
Windows:  
Entry Door water stains and debris  
around floor area

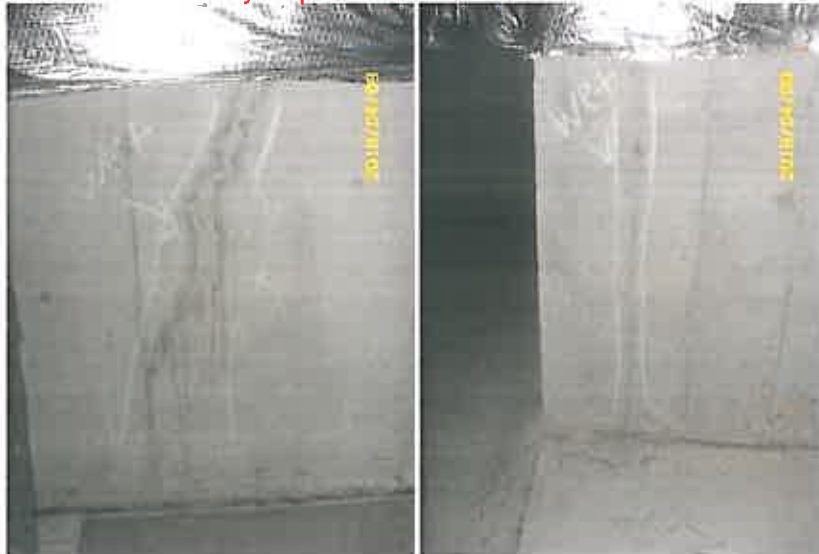
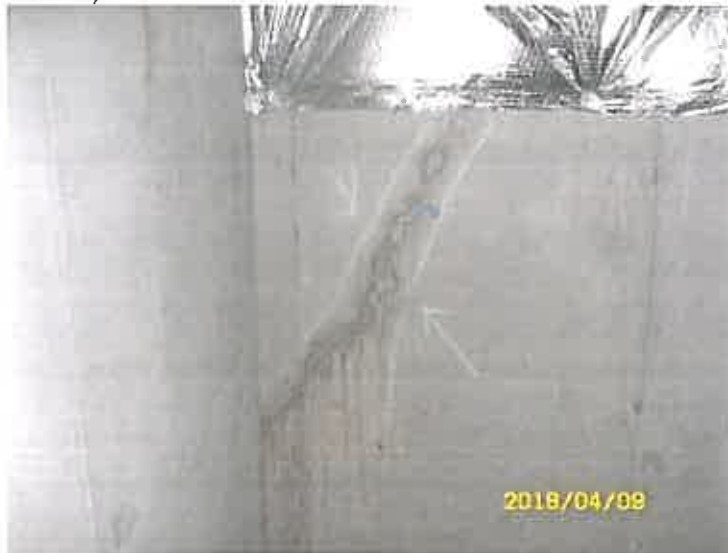
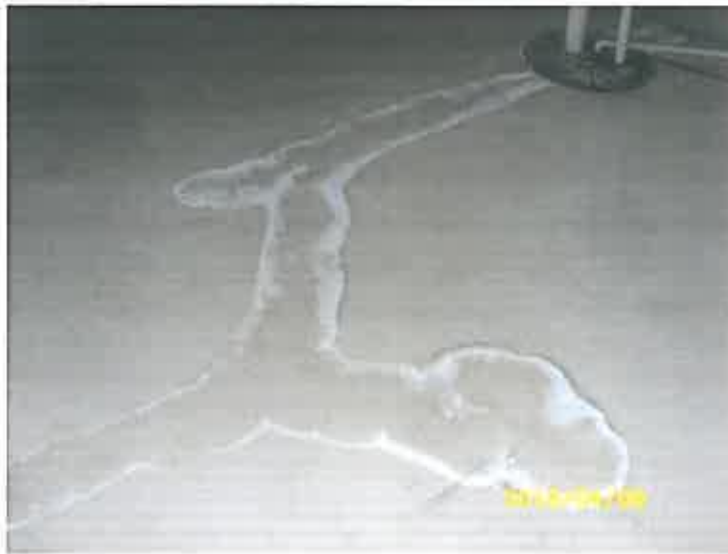
Moisture stains – many seen at walls and floor. Exterior foundation coating should be evaluated. This may require some excavation

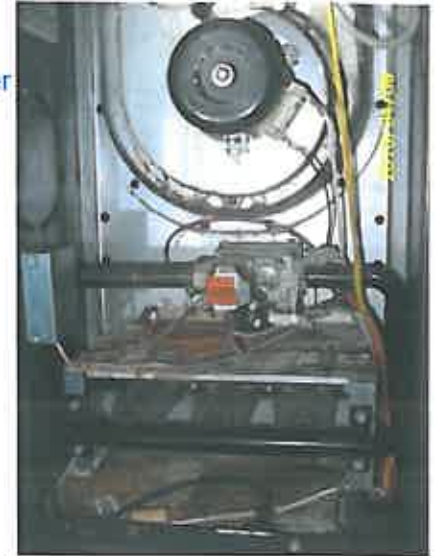
Forced Air Furnace / Operation condensate leak stains/rust at attic furnace area., Yearly service recommended. Note – fan was continuously running at lower zone furnace

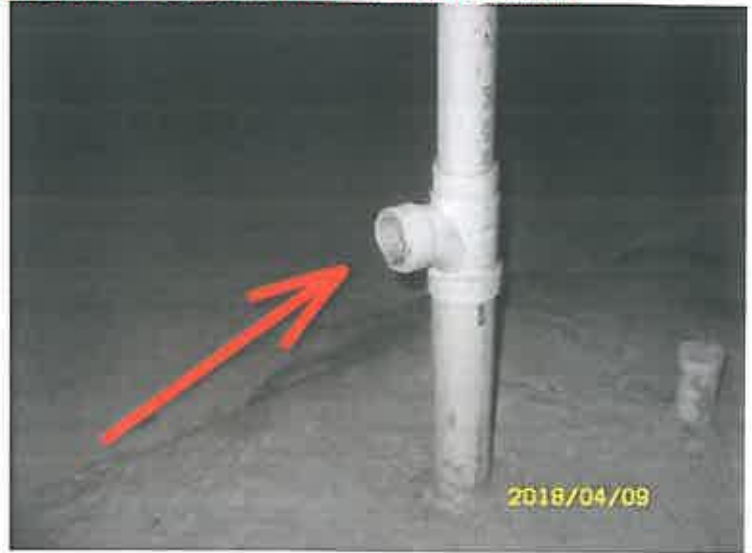
**Not Inspected** Main Water Shutoff: Location **Basement front wall**  
**For Your Information** Water Service Entry Line Material **not accessible, covered by a corrugated sleeve**  
**Satisfactory** Copper Water Supply Pipes **used at sprinkler system**  
**Unsatisfactory** CPVC Water Supply Pipes  
**Unsatisfactory** Shut off Valves – **dripping at hose bib shut off. Located at front wall of basement**  
**Unsatisfactory** PVC Drain Pipes – **open ended/broken pipe at bathroom rough in area. Sewer gas infiltration is possible**

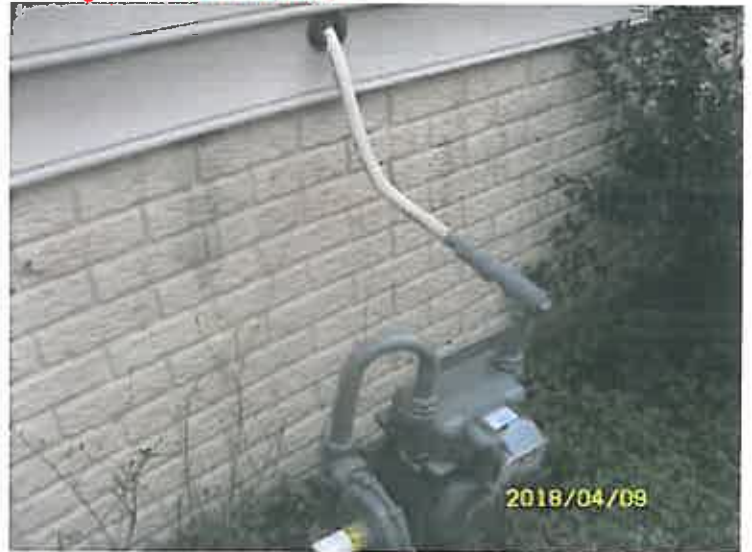
**Unsatisfactory** Cleanout Caps – **loose and needs sealing at water main area**  
**Unsatisfactory** CSST Type Gas Lines **Needs to be properly grounded by master electrician. See information paper supplied as separate email attachment**

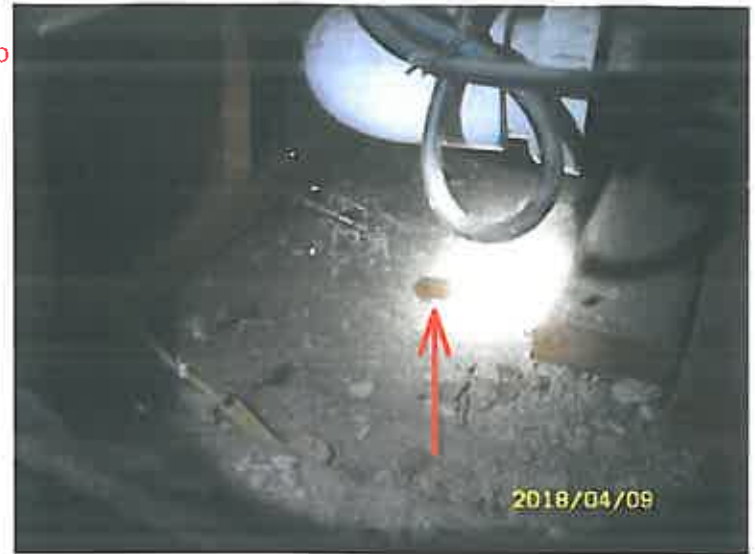
Satisfactory Exhaust Fan  
 Unsatisfactory Sink **drain leaking**  
 Satisfactory Toilets  
 Satisfactory Seperate Shower  
 Unsatisfactory Jetted Tub **pump motor not staying on. Leaking pipe under tub**
